# San Elijo Ocean Outfall 2017 Annual Inspection Report

**Prepared for San Elijo Joint Powers Authority  
Cardiff by the Sea, CA  
March 2018**

**Prepared By:**  
Undersea Graphics, Inc.

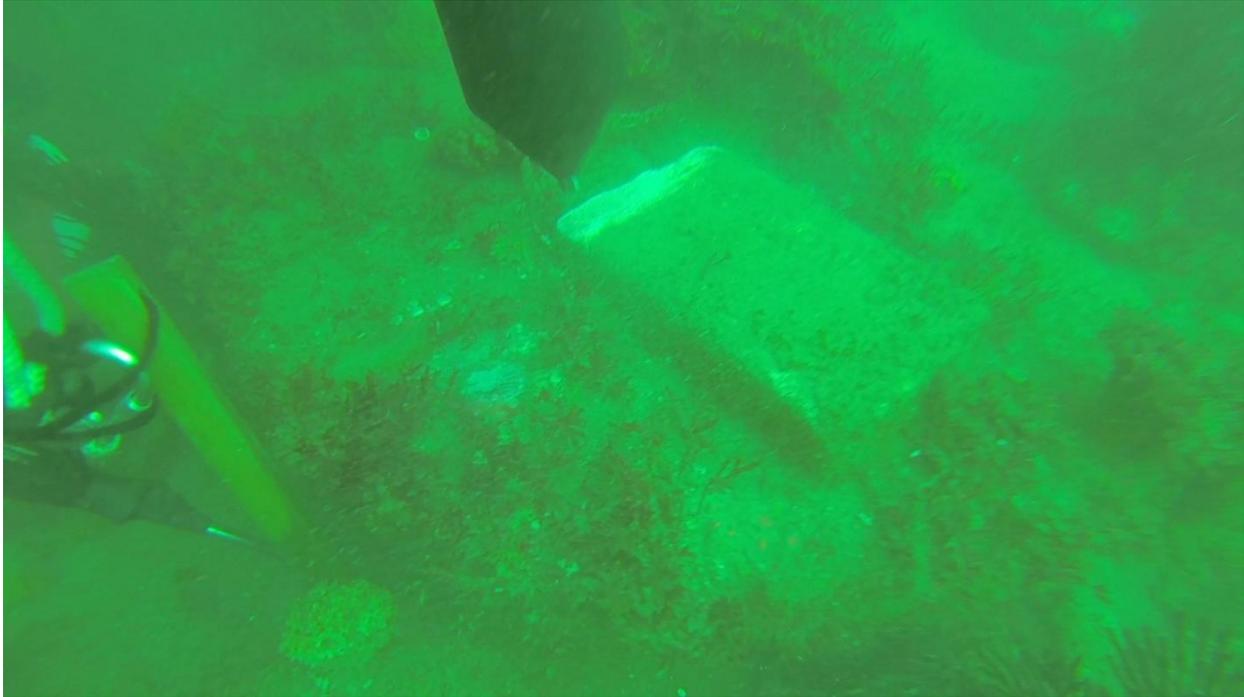
Portholes 1, 2, and 3 were inspected. Visual inspection of the portholes revealed the portholes and associated zinc anodes to be in fair to good condition (Figure 3). There were no signs of concrete spalling, leaks, or fractures. Cathodic protection (CP) readings on zinc anodes were also conducted. Data from the 2017 survey, as well as for CP readings from the previous three years of surveys, are presented in Table 1. The areas of portholes 4 and 5 were visually inspected but the portholes themselves were not located due to sand buildup in this area. Again, there were no signs of concrete spalling, leaks, or fractures in these areas. Two numbers in the "% Estimated Remaining Anode Mass" column indicate that two anodes are connected to a single porthole.

Figure 5. Porthole cover with zinc with approximately 90% remaining life expectancy.

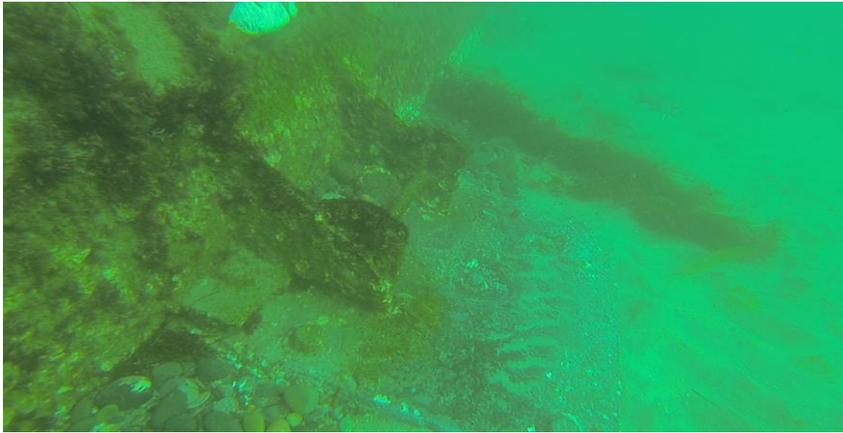
In July, efforts were made to locate pile supports, but none were exposed as migratory sand covered all pile supports. In December, the inspection team was able to locate and inspect 5 of the 35 pile supports. All of the exposed pile supports have good working anodes attached. Cathodic protection (CP) reading data from the 2017 survey, as well as for CP readings from the previous four years of surveys, are presented in Table 2. Two numbers in the “% Estimated Remaining Anode Mass” column indicate that two anodes are connected to a single pile support.

Figure 6. Exposed pile support

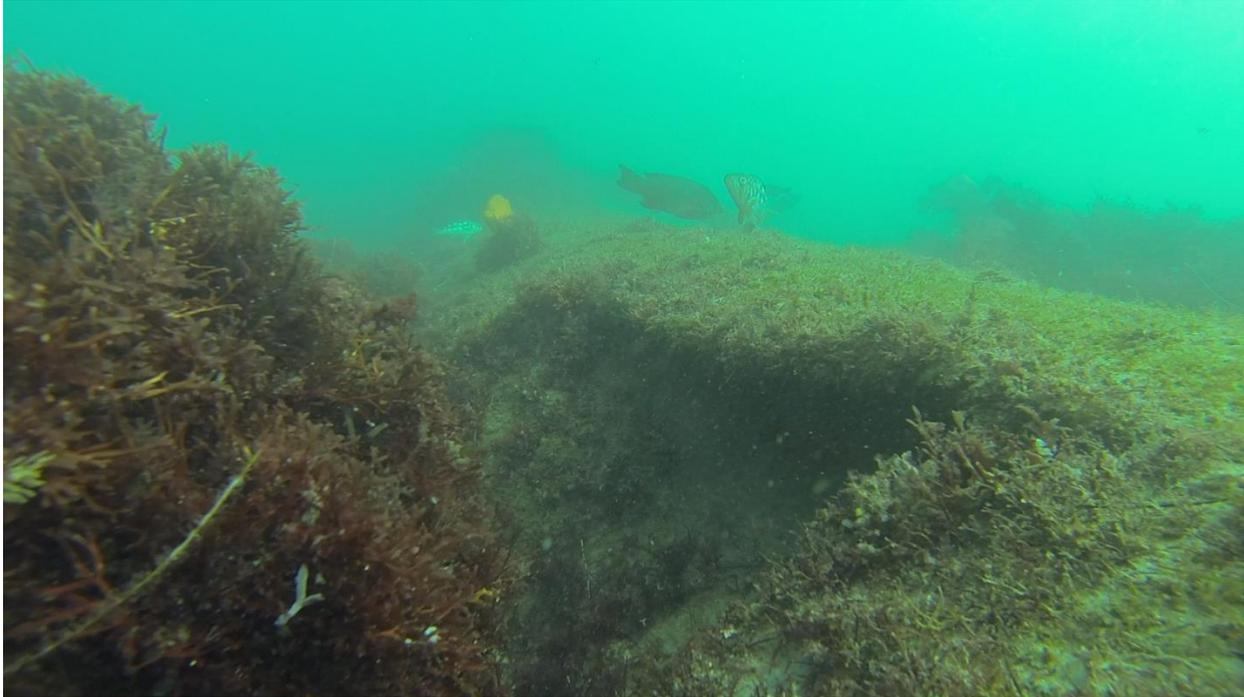
Figure 7. View of protective cowling
