San Elijo Joint Powers Authority San Elijo Water Reclamation Facility

OUTFALL INTEGRITY REPORT

FINAL | January 2020

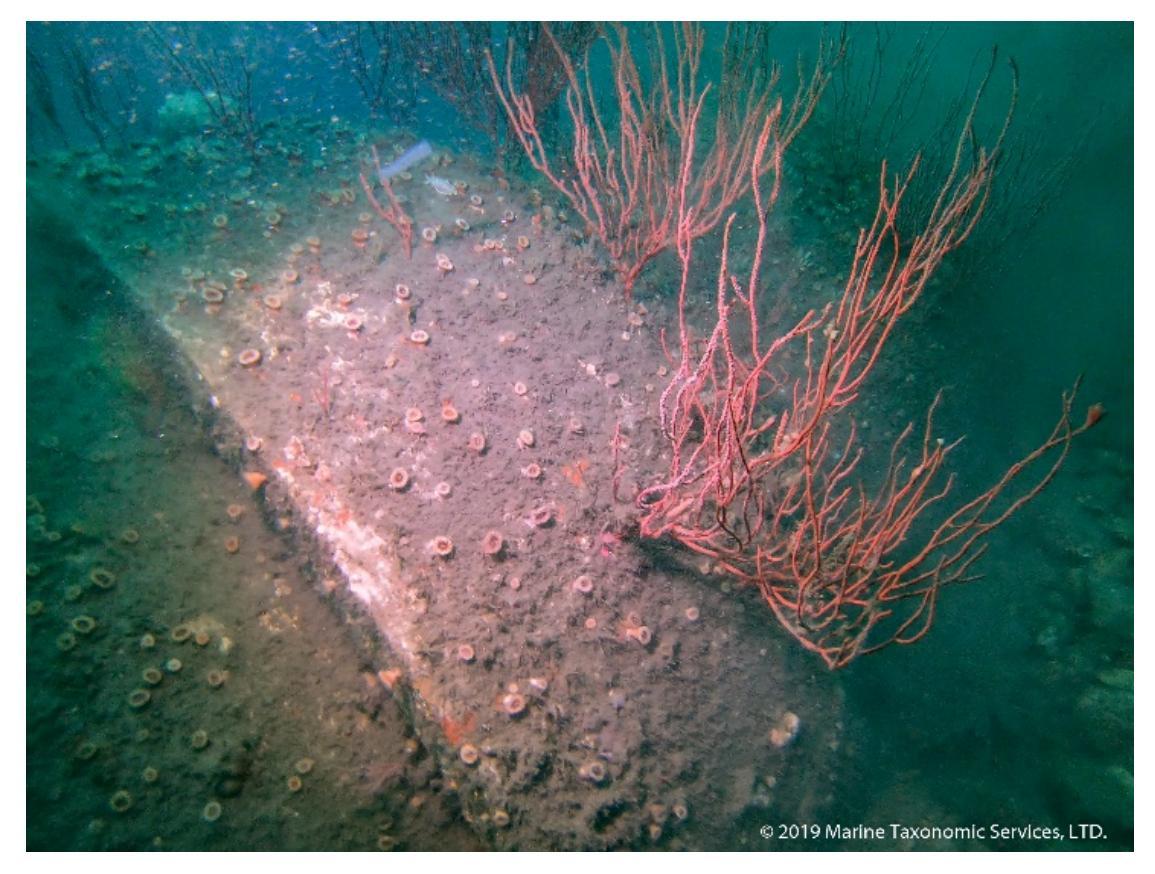
Figure 4 Marine Growth on Joint and Piping

General inspection of the ocean outfall consisted of visual examination of the exposed sections of the RCP. The visible portions were in good condition and showed no signs of spalling or other deficiencies. All observed joints were in alignment and showed no signs of leaking.

Growth of marine plants and animals on artificial surfaces is a common occurrence when they are submerged for an extended period of time. Although some evidence of marine growth was found, it was minimal and not believed to affect the outfall piping. Figure 4 shows a portion of the outfall pipe showing signs of marine growth.

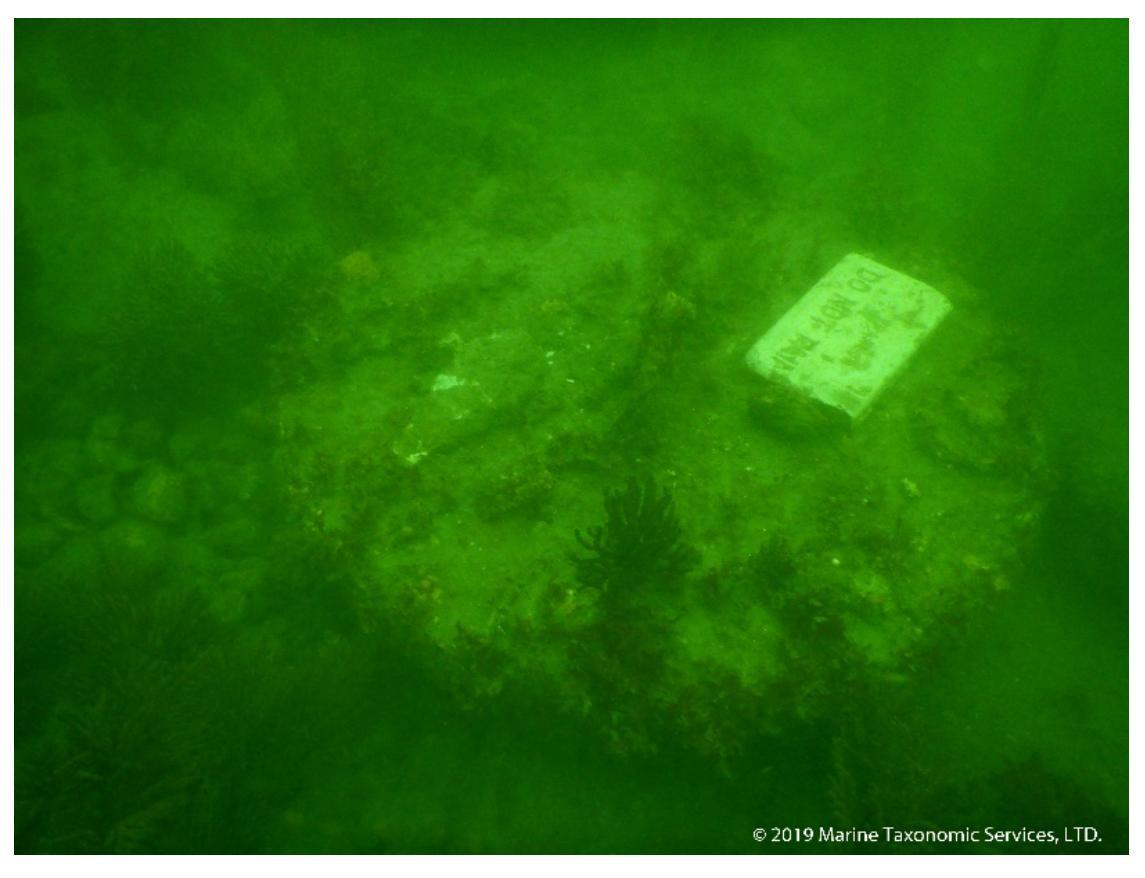
Figure 5 Porthole No. 3

All portholes and anodes were visually inspected and were found to be in good condition. Cathodic protection readings were taken, all having an estimated remaining anode mass of

60 percent. The portholes showed no signs of spalling, leaks, or fractures. Figure 5 shows Porthole No. 3 and surrounding rock ballast with marine growth.

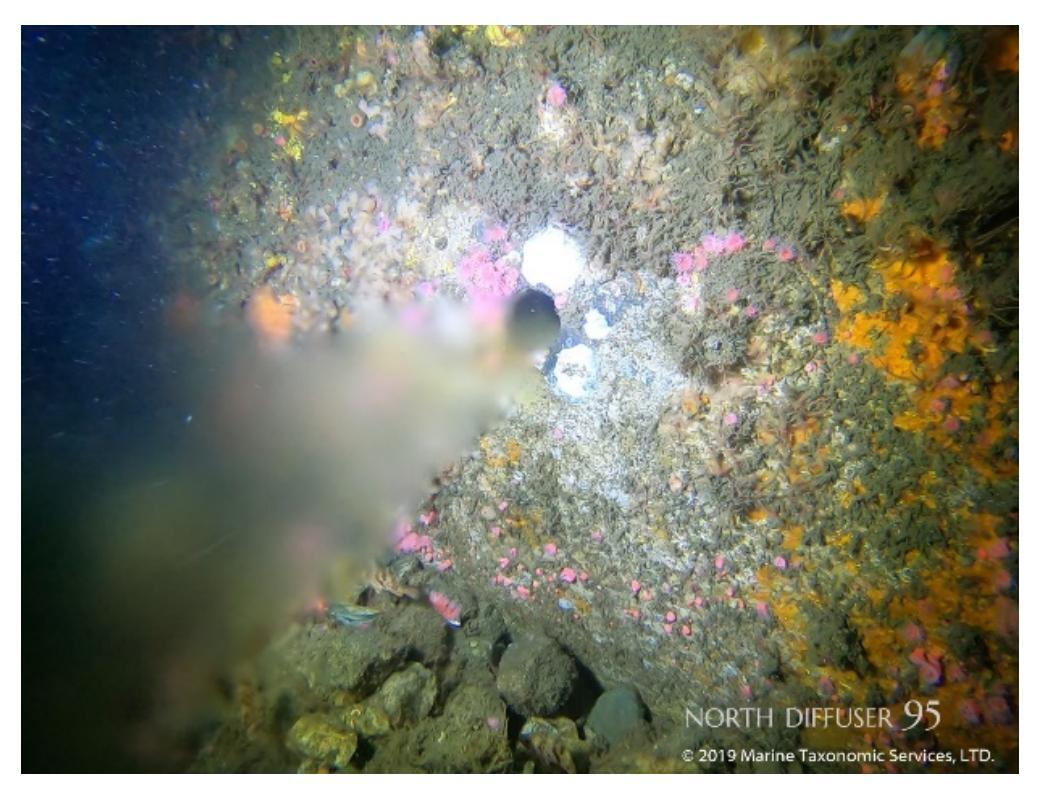
Figure 6 Clear Diffuser Port

The final diffuser section is composed of two hundred 2-inch nominal diameter diffuser ports for effluent discharge. Diffuser holes will often become partially clogged due to growth of marine life. Figure 6 shows an open and clear diffuser port. All diffusers were flowing well, and any marine growth that was found immediately around the diffuser ports was removed.

- Complete a ROV or rebreather-based dive survey of the diffuser section of the outfall pipe as needed to clear any blocked ports.
- Continue to survey for and cut kelp on the pipeline and ballast pile to keep additional ballast from moving away from the pipeline.
- Monitor for re-emergence of all 35 pile support structures, complete structural inspection of anodes, and add them once they re-emerge from the littoral sands. The anodes seem to be exposed the most in the winter months.

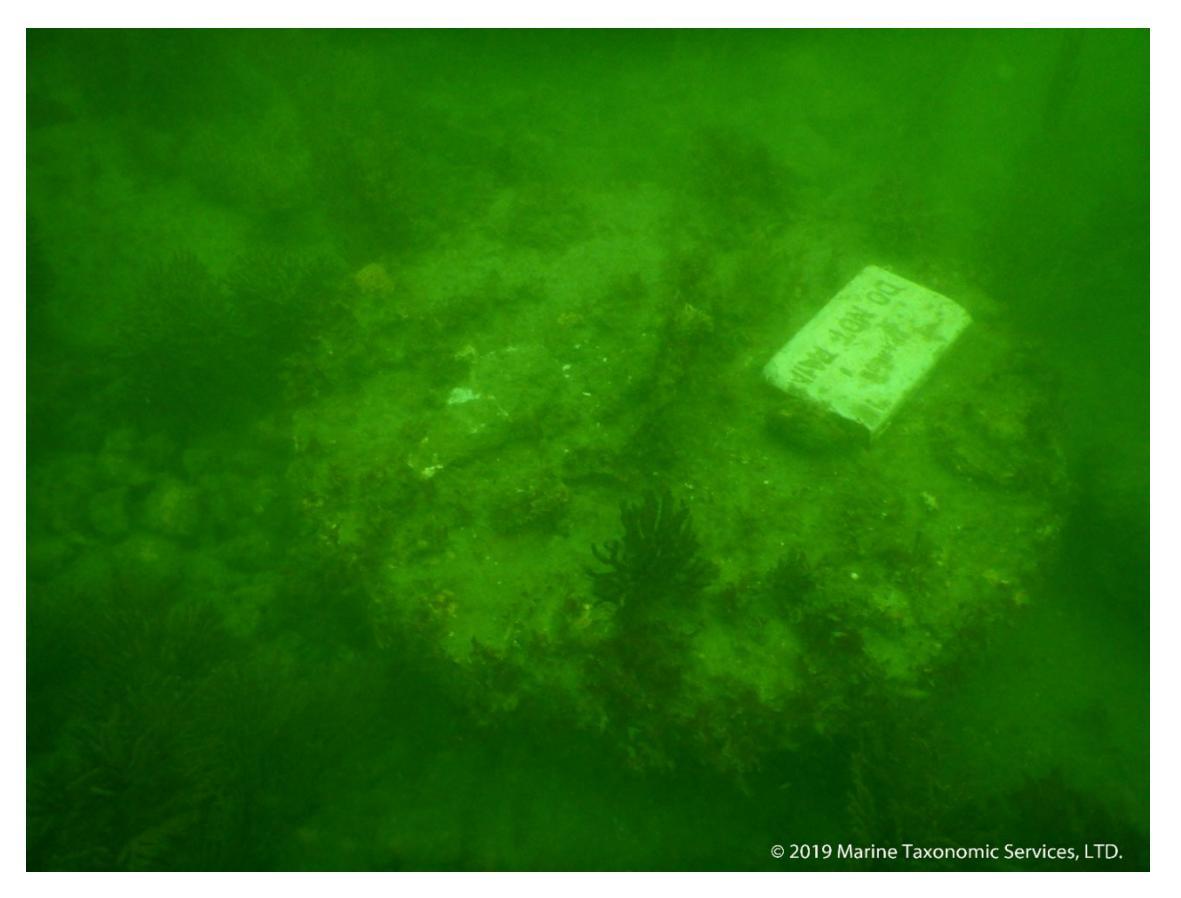
All portholes were inspected. Visual inspection of the portholes revealed the portholes and associated zinc anodes to be in fair to good condition (Figure 3). There were no signs of concrete spalling, leaks, or fractures. Cathodic protection (CP) readings on zinc anodes were also conducted. Data from the 2019 survey, as well as for CP readings from the previous three years of surveys, are presented in Table 1.

Figure 3. Porthole cover with zinc with approximately 60% remaining life expectancy.
