AGENDA
REGULAR BOARD MEETING OF THE
SAN ELIJO JOINT POWERS AUTHORITY
MAY 19, 2026 AT 8:30 A.M.
SAN ELIJO WATER CAMPUS – BOARD MEETING ROOM
2695 MANCHESTER AVENUE
CARDIFF BY THE SEA, CALIFORNIA

SUBJECT: UPDATE OF EMERGENCY REPAIRS (APRIL) TO RECYCLED WATER PIPE
ON SAN ELIJO WATER CAMPUS

SUBJECT: NOTICE OF EMERGENCY SITUATION AND AWARD OF CONSTRUCTION CONTRACT FOR REPAIRS TO RECYCLED WATER PIPELINE ON THE SAN ELIJO WATER CAMPUS AT EAST ENTRY GATE

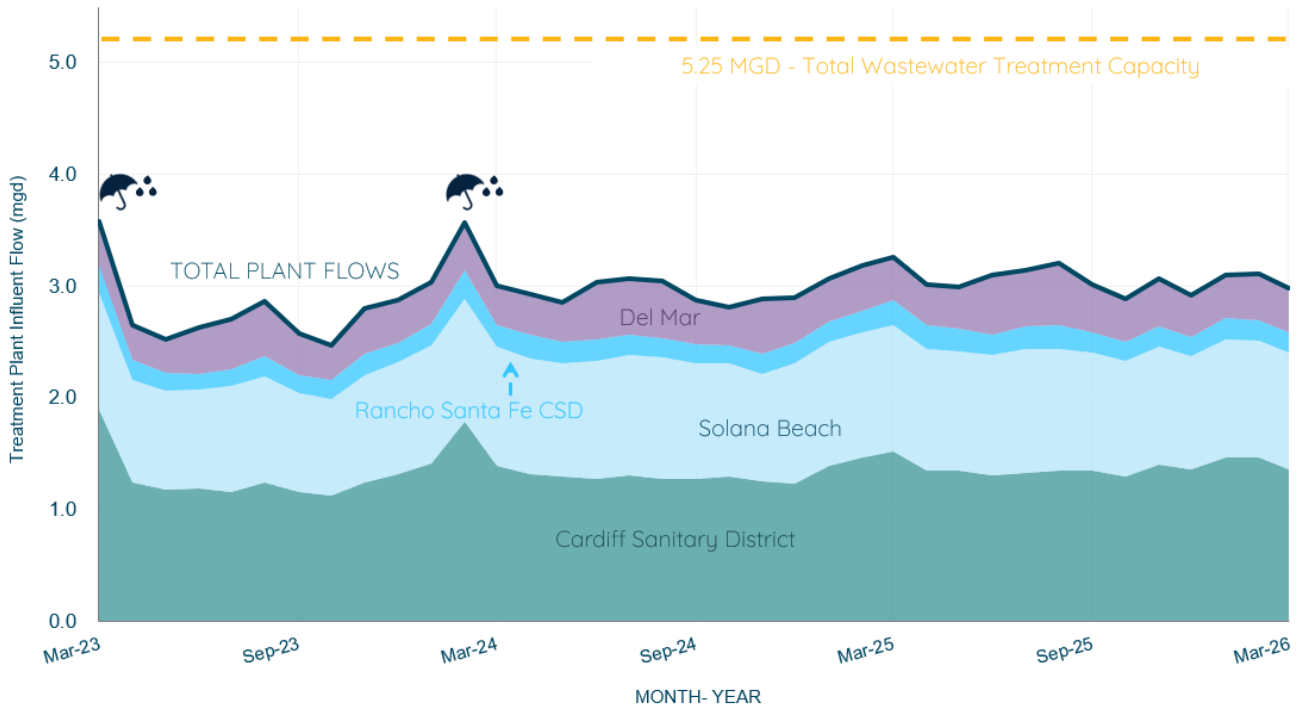
FIGURE 4: SEJPA AVERAGE DAILY FLOWS OVER THE PAST 3 YEARS

Figure 4 (below) presents the 3-year historical average daily flows per month for each contributing agency. This is to provide a historical overview of the average flow treated for each agency. Also shown in Figure 4 is the total wastewater treatment capacity of the water campus, 5.25 mgd, of which the Cities of Encinitas and Solana Beach each have the right to 2.2 mgd, Rancho Santa Fe Community Service District leases 0.25 mgd, and the City of Del Mar leases 0.60 mgd.

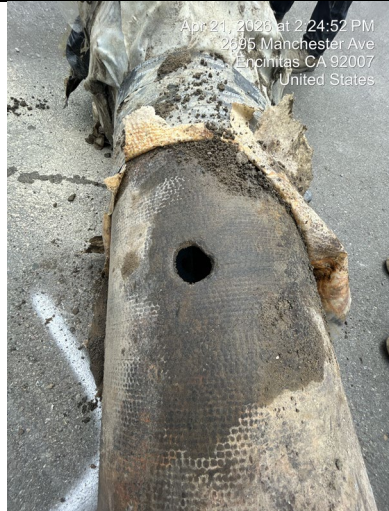
On April 20, 2026, at approximately 3:30 p.m., staff observed water surfacing through the asphalt parking lot at the Campus. Staff isolated the leak and closed the affected area for safety. Burtech Pipeline was contacted and mobilized a construction crew and equipment by 7:00 a.m on April 21, 2026. The Contractor’s crew located the leak, excavated the area around the pipe, cut and removed the damaged portion of pipe and installed a new piece of 12” pipe with repair couplings, backfilled and pressure tested the repair by the end of the day, April 21st. The Contractor returned later in the week to install a temporary asphalt patch.

April 20, 2026
Leak Observed in Parking Lot

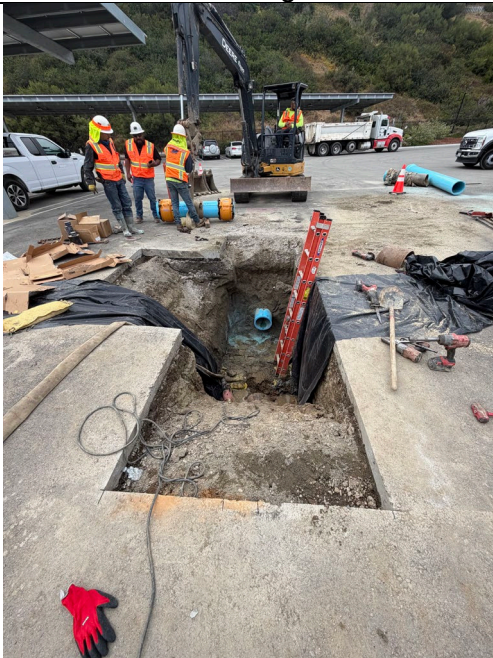
The damage was determined to be caused by exterior corrosion through the wall of the buried ductile iron pipe. This area of the San Elijo Water Campus is known to have corrosive soils and SEJPA has experienced similar pipe leaks on buried metal pipes in this localized area. The buried ductile iron pipe in this area of the plant will be identified for replacement as a capital project in the upcoming Facility Plan.

April 21, 2026
Hole in exterior of 12" ductile iron pipe

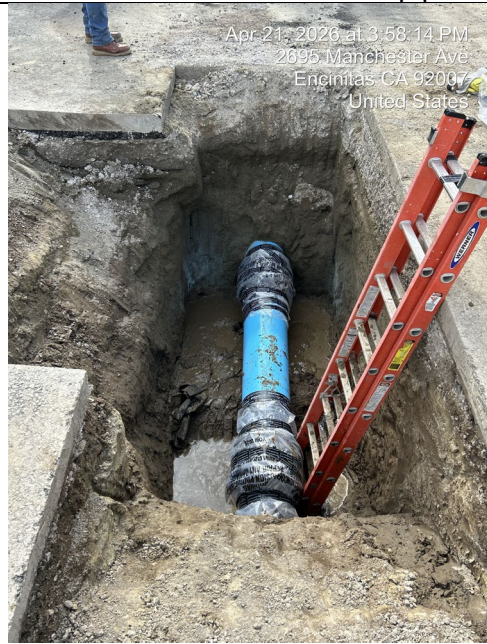
April 21, 2026
Pipe excavation

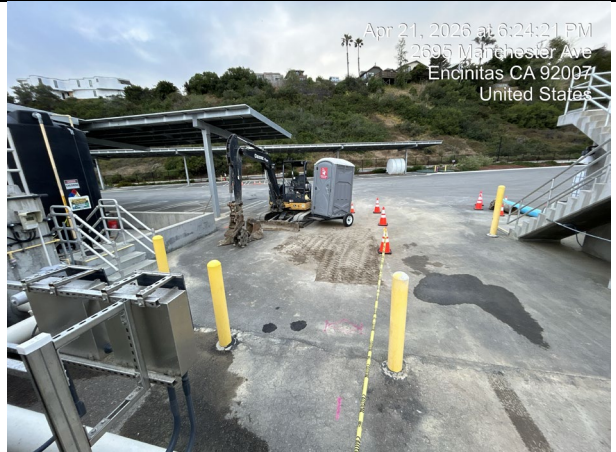
April 21, 2026
Backfill of Excavation

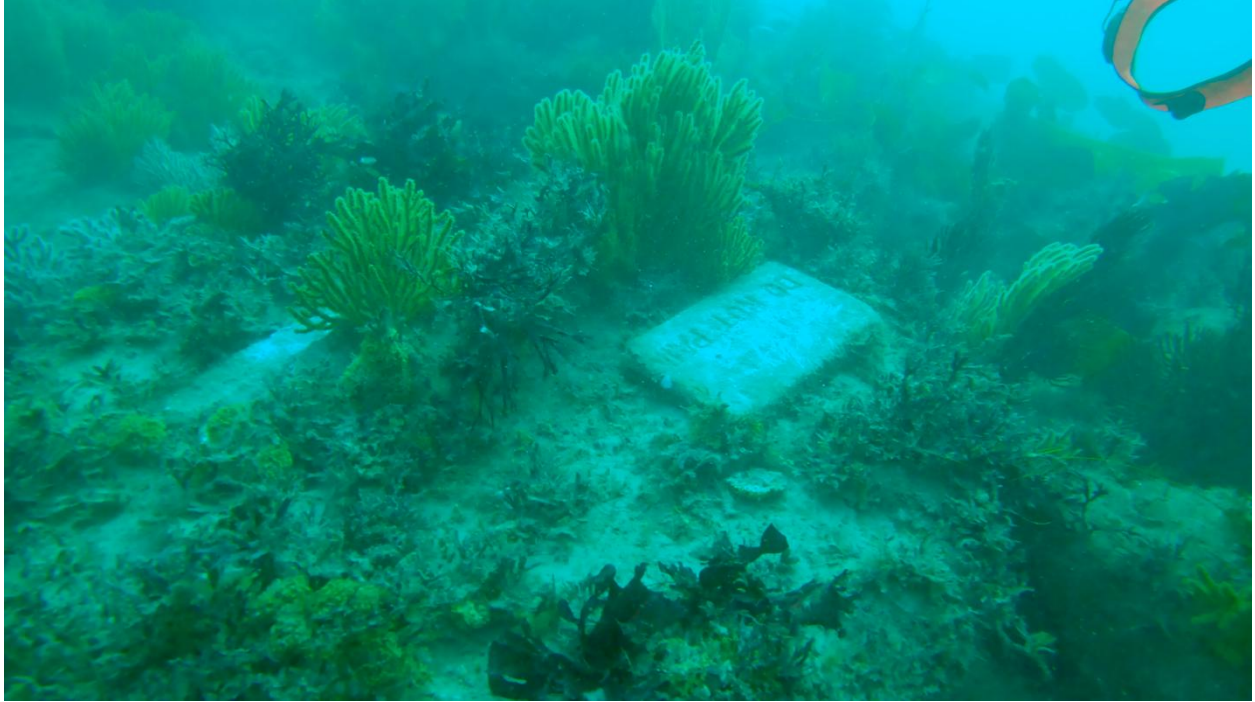
Visual inspection of portholes 2 and 3 revealed the portholes and associated zinc anodes to be in fair to good condition (Figure 2). There were no signs of concrete spalling, leaks, or fractures. Cathodic protection (CP) readings on zinc anodes were also conducted and the anodes were cleaned of oxidized material and fouling organisms. Data from the 2025 survey, as well as for CP readings from the previous five years of surveys, are presented in Table 1. Cathodic protection (CP) readings and% estimated remaining anode mass results from the 2016-2025 surveys. Readings were not taken in 2018 or 2020. "N/A" indicated portholes that could not be observed. Estimated anode remaining increased from 2017 to 2019, however, anodes were not replaced between surveys. The low values during the current survey are suspected to be in error and due to a problem with the meter.. Due to suspected electrical issues with the CP meter in 2025, readings for Portholes 2 and 3 were substantially lower than in previous years and are suspected to be inaccurate. Visual observations of the anodes and porthole covers give every indication that the structures are currently cathodically protected.

Porthole 2 and porthole 3 had a 1-inch and 0.5-inch-thick biofouling layer, respectively. All exposed portholes are shown in the video data provided with this report. Locations where shell hash obscures portholes 1, 4, and 5 can also be seen in the video.

Figure 2. Porthole 3 cover with zinc anode with approximately 50% remaining life expectancy.
