San Elijo Joint Powers Authority San Elijo Water Reclamation Facility

OUTFALL INTEGRITY REPORT

FINAL | January 2020

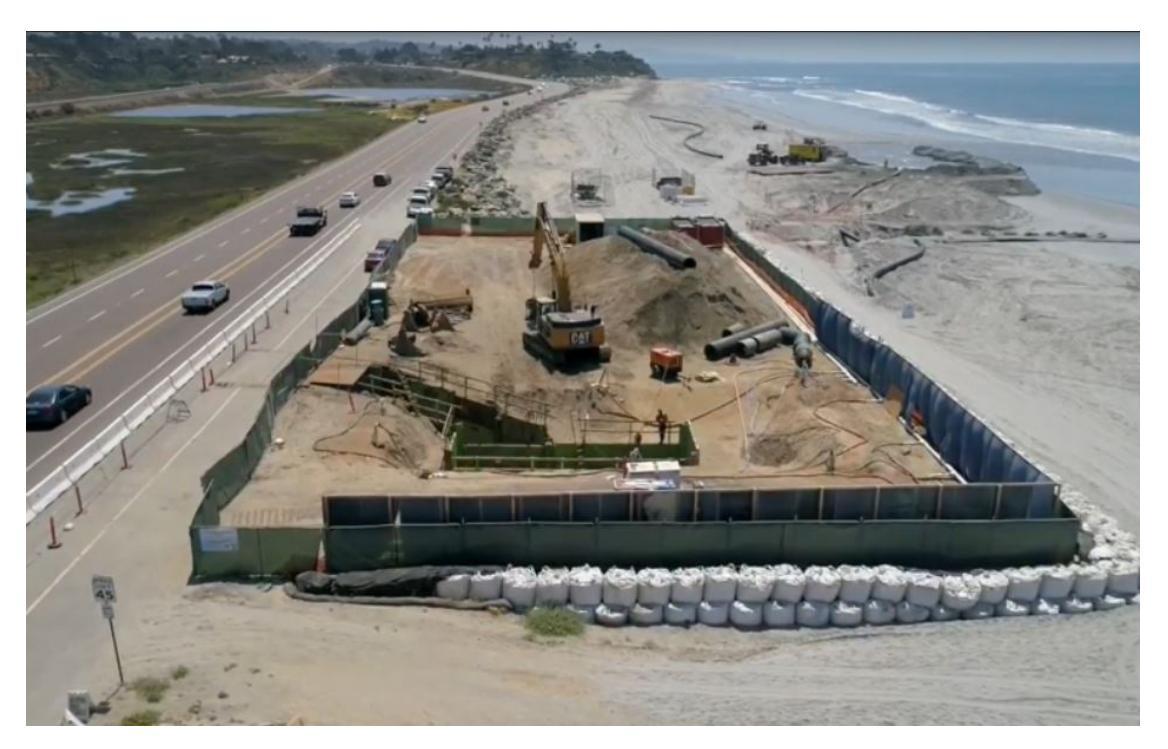
Figure 2 Land Outfall Launch Site

In 2018, SEJPA constructed a new land outfall with 30-inch HDPE pipe that connected to the existing 30-inch PVC pipe at the edge of the Facility, and abandoned the existing 30-inch AC pipe. The project also replaced the piping that connects the Escondido Regulator Structure to the outfall. The new land outfall was constructed utilizing horizontal directional drilling (HDD), which used remote micro tunneling to drill and install the new HDPE piping beneath the San Elijo Lagoon, the North County Transit District (NCTD) railroad, and Pacific Coast Highway. The drilling began at a launching site at San Elijo State Beach, shown on Figure 2, near the existing ocean outfall. The pipe descends to a depth of 70 feet below grade before ascending to a receiving site at the Facility for final connectivity.

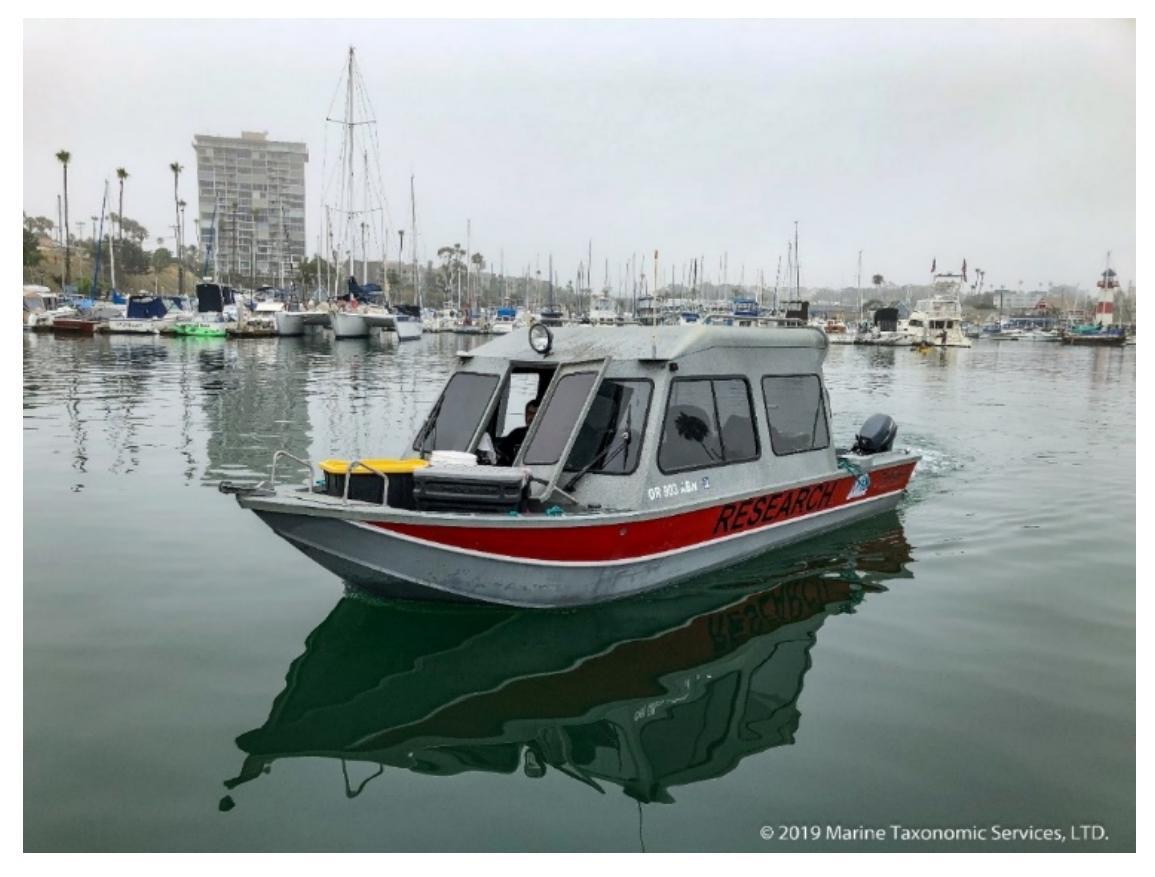
Figure 3 MTS Dive Vessel

MTS used a 22-foot aluminum survey vessel, shown on Figure 3, to perform their dives and inspect the ocean outfall. For each dive, the vessel launched from the Oceanside Harbor and transported the dive equipment to the dive site. The dive equipment included rebreathers for the two-person dive team and handheld video cameras for each side of the pipeline. The divers used a Nikon COOLPIX AW130 camera and a GoPro digital camera. After each dive, the dive equipment was inspected to ensure it was working properly.

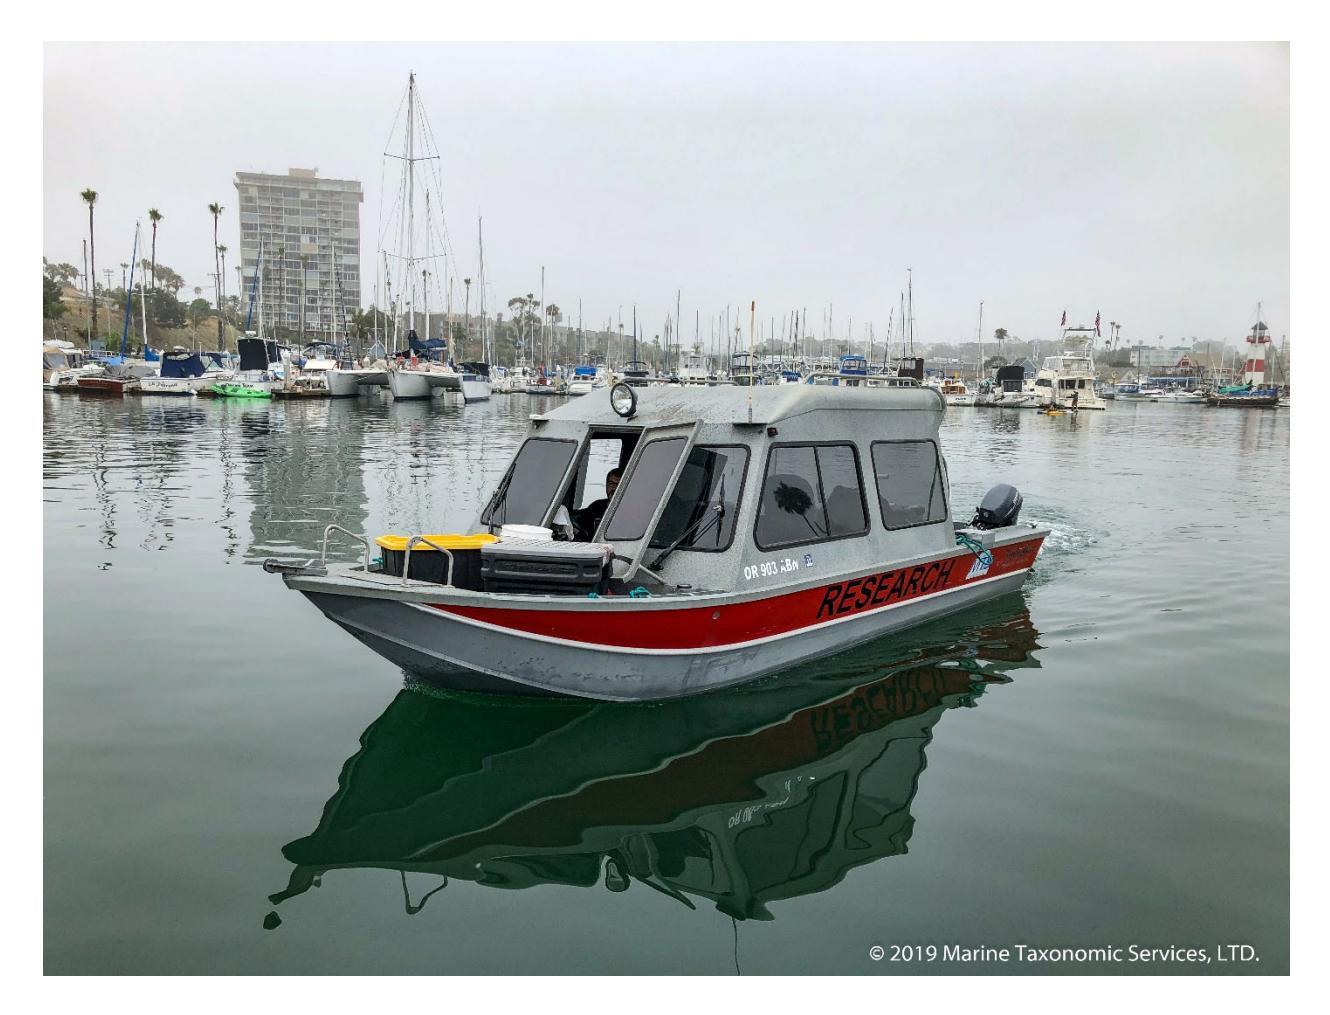
Figure 2. The Koffler.

The MTS marine research vessel, The Koffler (Figure 2), was mobilized for the outfall inspection. The Koffler, a 22-ft aluminum survey vessel, was selected as the diving platform. The vessel was equipped with all essential diving, navigational and inspection equipment.

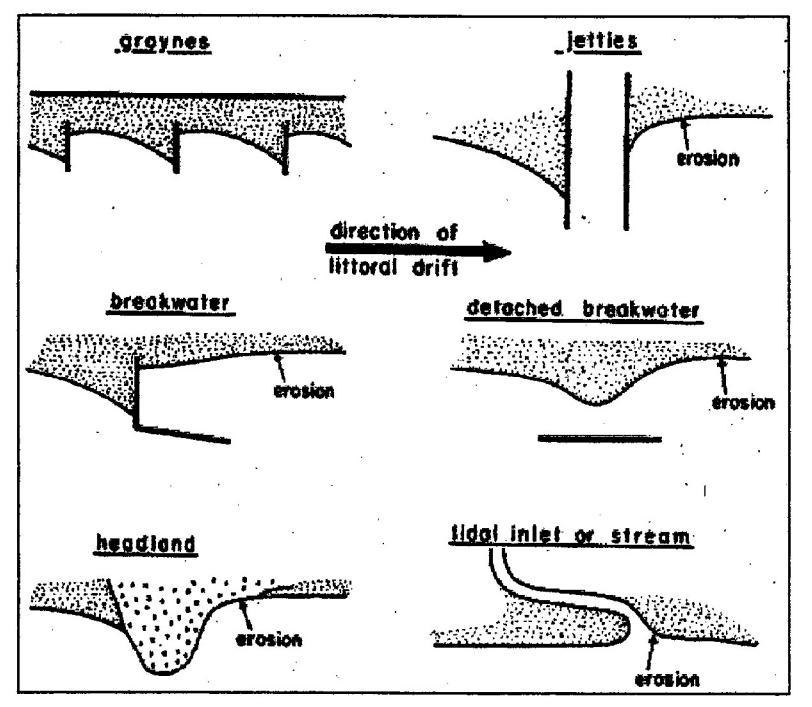
Figure 5-2 Deposition and erosion due to interruption of longshore transport

Scour results in the loss of sand around the toe of the ballast pile, around the pipe, and supporting structures where no ballast exists. Excessive scour can lead to ballast pile setting or collapse and weakened support foundation, which eventually may result in unsupported spans of pipe.
