# San Elijo Ocean Outfall 2017 Annual Inspection Report

**Prepared for San Elijo Joint Powers Authority  
Cardiff by the Sea, CA  
March 2018**

**Prepared By:**  
Undersea Graphics, Inc.

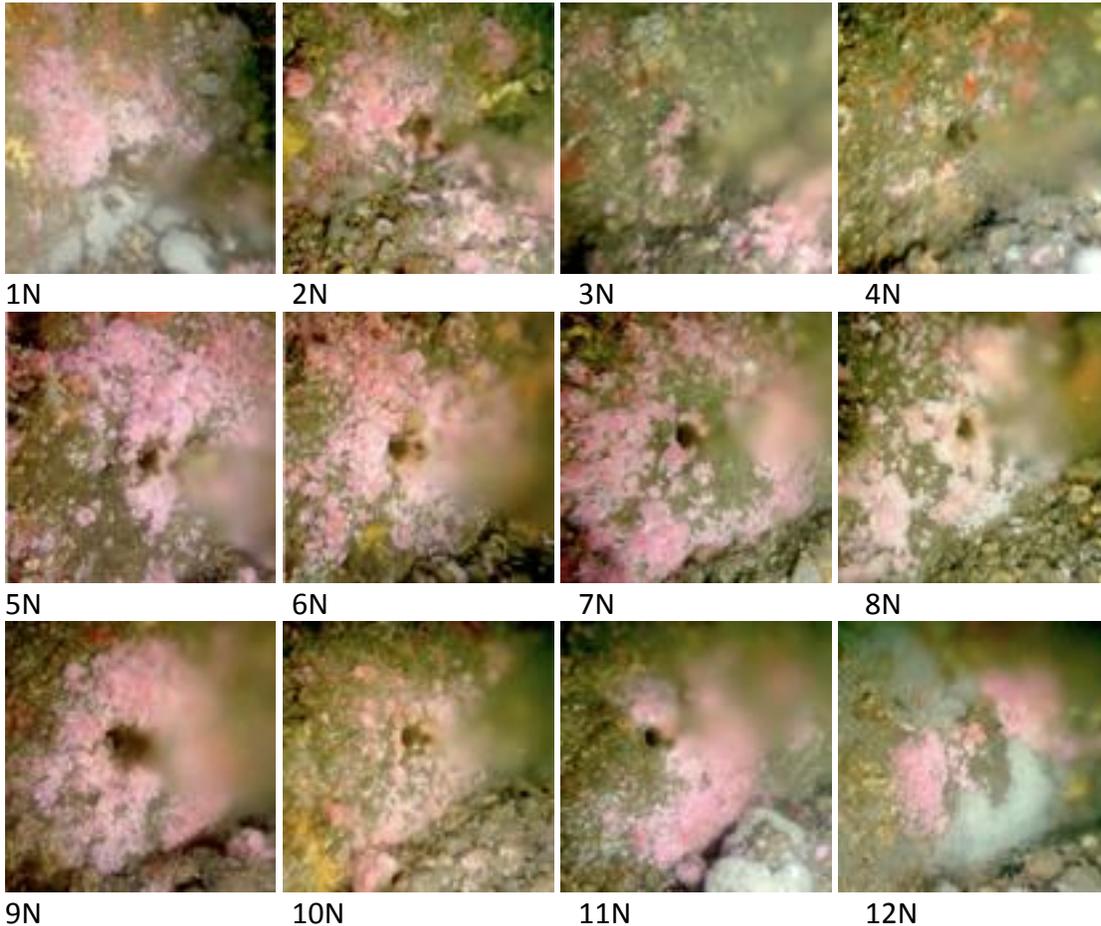
13N

The following port book consists of a photograph of each of the 200 ports. They are labeled 1N-100N, which indicates the north side of the outfall and 1S-100S indicating the south side of the outfall. Both 1N and 1S are the most inshore diffuser ports around Station 66+00; whereas 100N and 100S are the most offshore diffuser ports at Station 81+00.
